Site monitoring report

Site Name: Highwood Quarry, Stortford Road, Little Canfield

Date: 1 August 2024

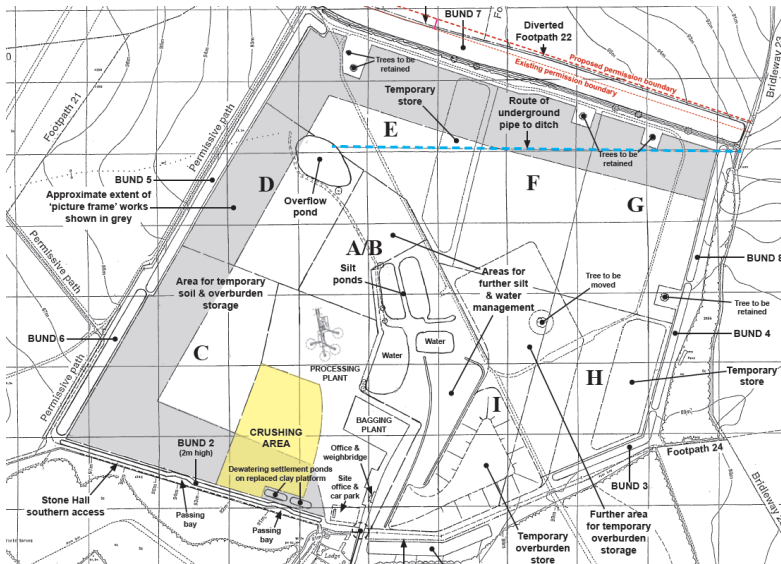
While the large bunds (east and north of site) are well maintained the western boundary is a mass of weeds, the seeds are likely to drift onto the restored area and agricultural land beyond – it essential they are trimmed to reduce weeds and improve appearance.

Screening bund on the western boundary to be maintained, weeds trimmed and then treated to suppress weeds.
