Site monitoring report

Site Name: Bradwell Quarry

File Ref: 12 421 10

Date: 28 November 2024

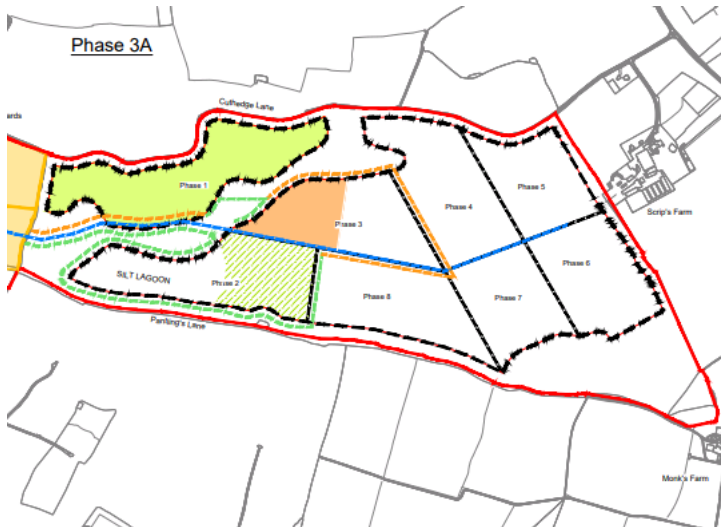
Phase 3 archaeology completed, overburden to be stripped spring 2025 west end.
