# Site monitoring report

**Site Name: Bulls Lodge Quarry, Generals Lane, Boreham, Essex, CM3 3HR**

**Visit no:** 3 of 4

**Date:** 4 Nov 2024

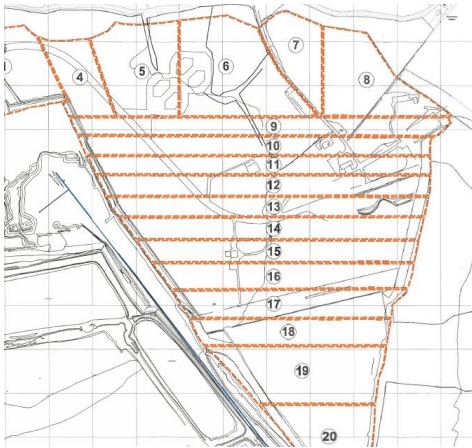
#### Extraction area Airfield

Archaeology complete in west end of phases 14, 15 and 16 allowing extraction to progress west across these phases.

A wedge of overburden has been located on the east side of phases 14, 15 and 16 where it abuts Original Phase 1, probably face support of Phase 1 when it was being worked and restored. It will require removal.

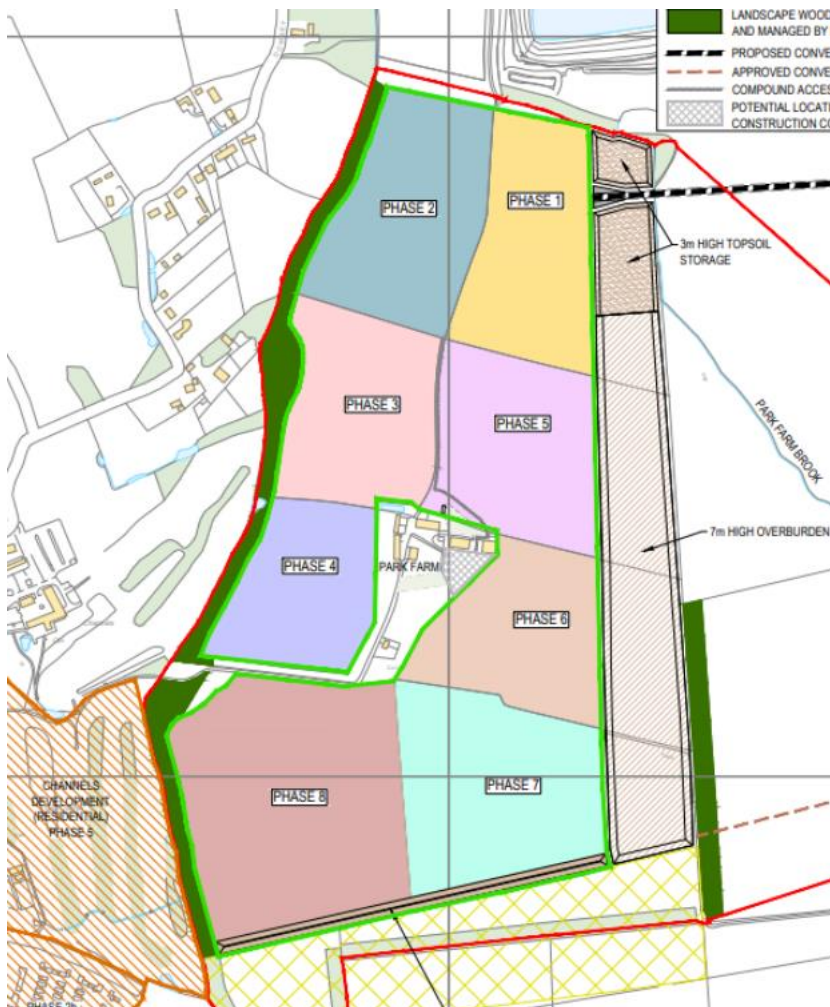
### Park Farm Extraction Area

Archaeology in Phase 1 and 2 and overburden/soil storage areas complete, except for one investigation trench required, to be undertaken when plant available. The post excavation report for these areas is outstanding.

There is a power cable to move, likely Q1 2025.

Archaeology planned for phases 3/4/5/6 in 2025, a WSI has not been approved by the MPA at this time. Trail trenching in Phase 3 undertaken previously, but not within remaining phases of Park Farm.
