# Site monitoring report

**Site Name:** Blackley Quarry, Gt Leighs, Chelmsford, Essex, CM3 1QP

**Visit no:** 3 of 4

**Date:** 9 Dec 2024

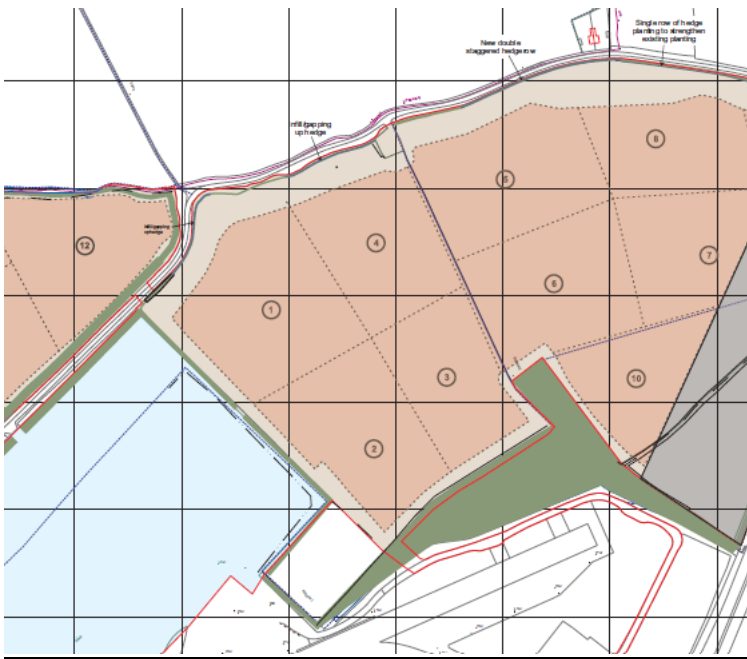
Extraction continuing in phase 5 and 6, some slope failure on north face. Overburden removal being placed on alignment of original footpath to aid its relocation in readiness for moving to phase 7 and 8. Dry screener and some plant being stored in phase 3.

Sand stockpile in Phase 2

Stand-off to Blackley Cottages from the excavation face was being maintained.
