# Site monitoring report

Site Name: Terminus Drive, Pitsea Hall Lane

File Ref: 32 457 09

ESS/13/15/BAS - WTS

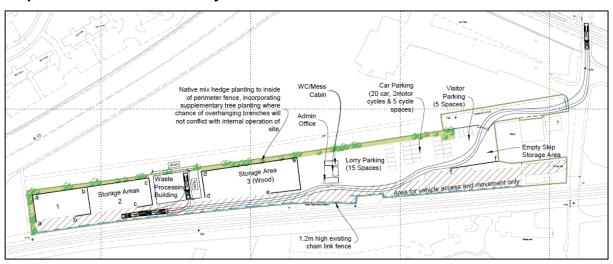
This area remains largely occupied by inert waste that requires screening. The stockpile was in excess of permitted 4 metres in places, approximately 5m. Some material has been removed, but the majority remains in place. There is a standoff to the railway line, but not to a width to be in accordance with the approved layout drawing, extract above.

The stockpile is visible from the elevated A13 Pitsea Flyover and from the adjacent PRoW. The stockpile prevents use of the western end of the site for inert waste recycling, ensuring it located as far away as possible from Cromwell Manor a Listed event venue.

HIGH PRIOIRITY Reduce inert stockpile west end of site to below 4m (condition 17 of ESS/13/15/BAS) and create at least a 2m stand off to fence with railway fencing in accordance with drawing ref 12.1831/P201 Rev Z.
