Site monitoring report

Site Name: Bulls Lodge Quarry, Generals Lane, Boreham, Essex, CM3 3HR

Operator: Hanson Aggregates

Date: 25 Feb 2025

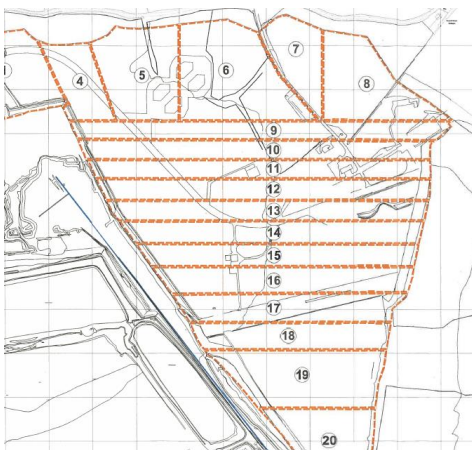
Extraction area Airfield

Overburden on the east side of phases 14, 15 and 16 where it abuts Original Phase 1 has been removed, to enable restoration.

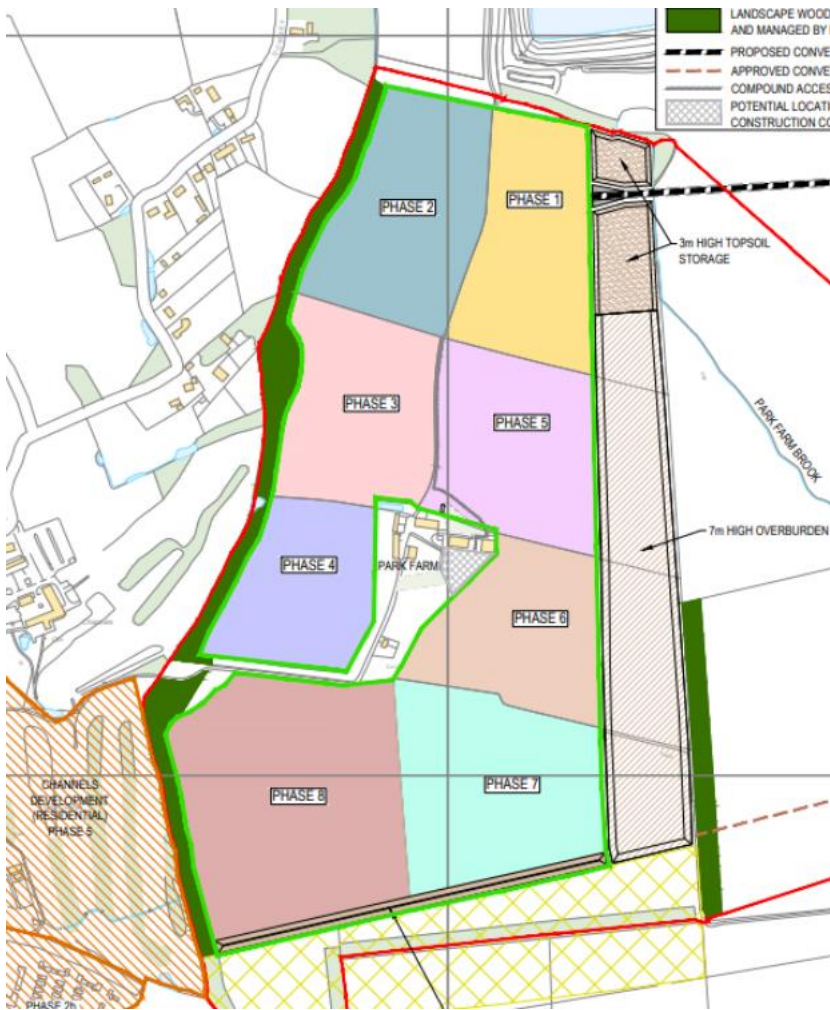
Park Farm Extraction Area

Archaeology in Phase 1 and 2 is largely complete, at last visit it was understood one investigation trench was required, to be undertaken when plant available. SP to check whether this has been completed. The post excavation report for these areas is outstanding.

Hedge on north edge of phase 1 has been laid and hedge on north side of Phase 2 gaps have been planted up.

It was noted that the route of the Park Farm Brook due to the stripping of topsoils has become infilled with washed in material such that water was running over an area of Phase 2.
