Site monitoring report

Site Name: Bulls Lodge Quarry, Generals Lane, Boreham, Essex, CM3 3HR

Operator: Hanson Aggregates

Date: 30 Aug 2024

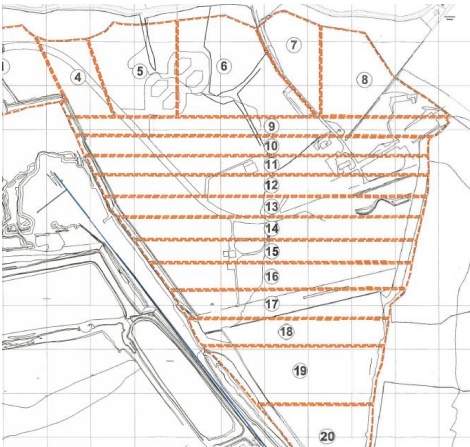
Extraction area Airfield

Topsoil completed in Phase 3 and northern edge of phases 4 5, 6, 7 and 8. Some areas grassed, but still to be seeded

Extraction nearly complete in east end of 14,15 and 16. LW anticipates they will strip west end of 14, 15 and 16, as commencement of extraction in Park Farm delayed due to electricity cable relocation.

Extraction not taking place at time of visit due to conveyor maintenance.

New sand faces away from extraction areas were created for sand martins

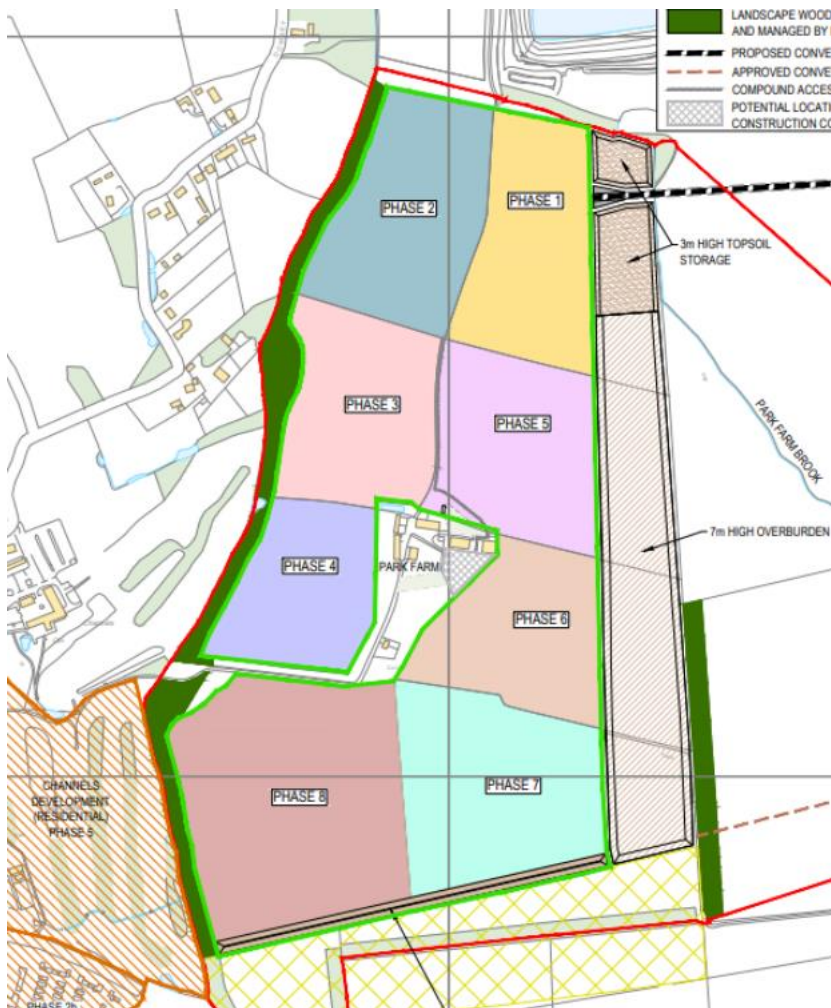
Park Farm Extraction Area

Archaeology in Phase 1 and 2 and overburden/soil storage areas complete, except for one investigation trench required, to be undertaken when plant available.

There is a power cable to move, likely Q1 2025.

Archaeology planned for phases 3/4/5/6 in 2025
